**FRM AVIATION SERVICES**

ESN: [REDACTED] - CFM56-7B BORESCOPE INSPECTION REPORT

CUSTOMER DATA:			ENGINE & AIRCRAFT DATA:		GENERAL ENGINE DISPOSITION	
CUSTOMER			A/C REG	OFF WING	LPC	MINOR DEFECT OBSERVED - SERVICEABLE
LOCATION	GT ENGINE SERVICES, STN		MSN	OFF WING	HPC	ALL OBSERVED DEFECTS WITHIN AMM LIMITATIONS
FRM WORKORDER	100040		A/C TYPE	OFF WING	COMBUSTOR	ALL OBSERVED DEFECTS WITHIN AMM LIMITATIONS
INSPECTION DATE:	09.09.2021		POSITION	OFF WING	HPT	ALL OBSERVED DEFECTS WITHIN AMM LIMITATIONS
TECHNICAL DATA:	B737-800 AMM		ENGINE P/N	CFM56-7B26	LPT	ALL OBSERVED DEFECTS WITHIN AMM LIMITATIONS
REVISION NO.	D633A101		ENGINE S/N		OVERALL	ALL OBSERVED DEFECTS WITHIN ENGINE MODULES WITHIN AMM LIMITATIONS WITHOUT REDUCED THRESHOLD INSPECTIONS. ENGINE SERVICEABLE
DATED	15.08.2021		HOURS (TSN)	71677:00		
FORM 1 REFERENCE	CAA FAA	100040	CYCLES (CSN)	29896		
FORM 1 REFERENCE	EASA	100040	LIMITATIONS	NONE	<b>ENGINE SERVICEABLE - NO LIMITATIONS</b>

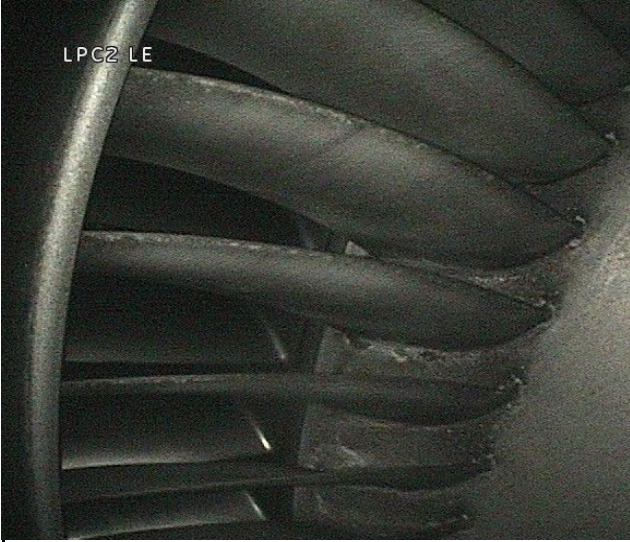
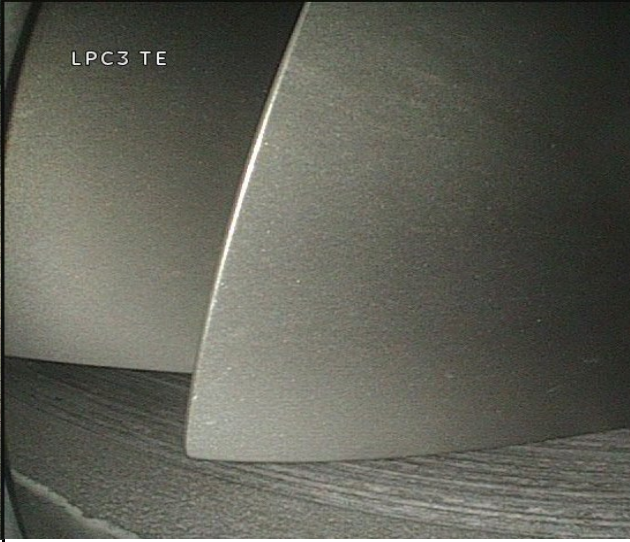
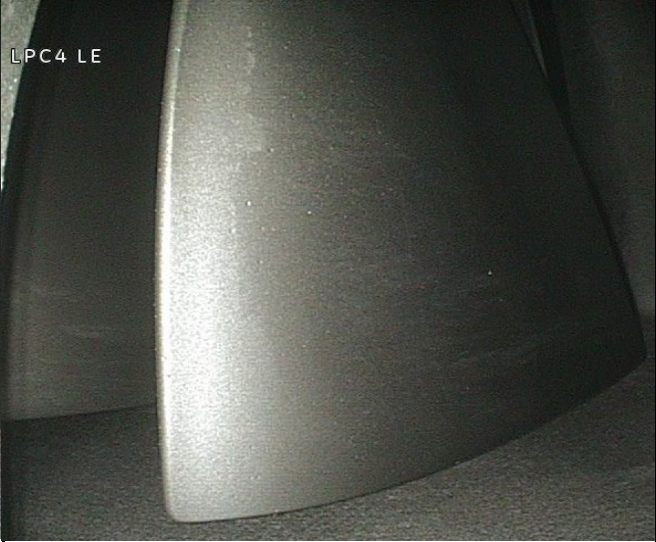
<p><u>STAGE 2 BLADES:</u> MINOR EROSION AND ENVIRONMENTAL BUILD UP OBSERVED TO BLADE LEADING EDGE.</p>	<p><u>STAGE 3 BLADES:</u> MINOR DENT OBSERVED TO LPC3 TE IN LOWER 25%, SEE LPC DEFECTS PAGE FOR DETAILS</p>	<p><u>STAGE 4 BLADES:</u> MINOR EROSION AND ENVIRONMENTAL BUILD UP OBSERVED TO BLADE LEADING EDGE.</p>
<p>NO IMAGE AVAILABLE</p>

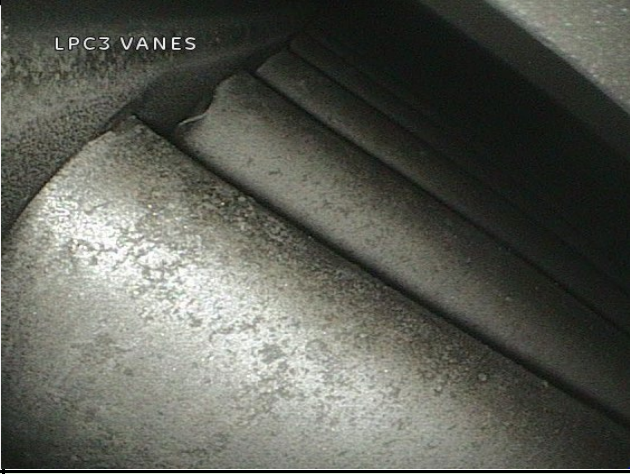
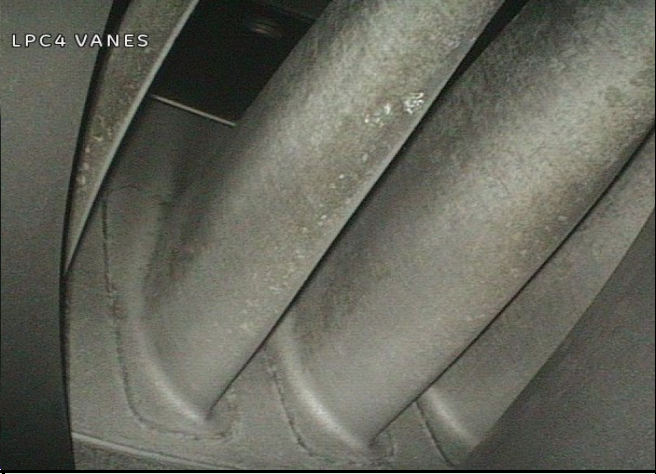
<p><u>STAGE 2 VANES:</u> INSPECTION OF STAGE 2 VANES NOT CARRIED OUT</p>	<p><u>STAGE 3 VANES:</u> MINOR EROSION AND ENVIRONMENTAL BUILD UP OBSERVED TO VANE LEADING EDGE.</p>	<p><u>STAGE 4 VANES:</u> MINOR EROSION AND ENVIRONMENTAL BUILD UP OBSERVED TO VANE LEADING EDGE.</p>
<p>LPC STAGE PICTURES (2-4)</p>

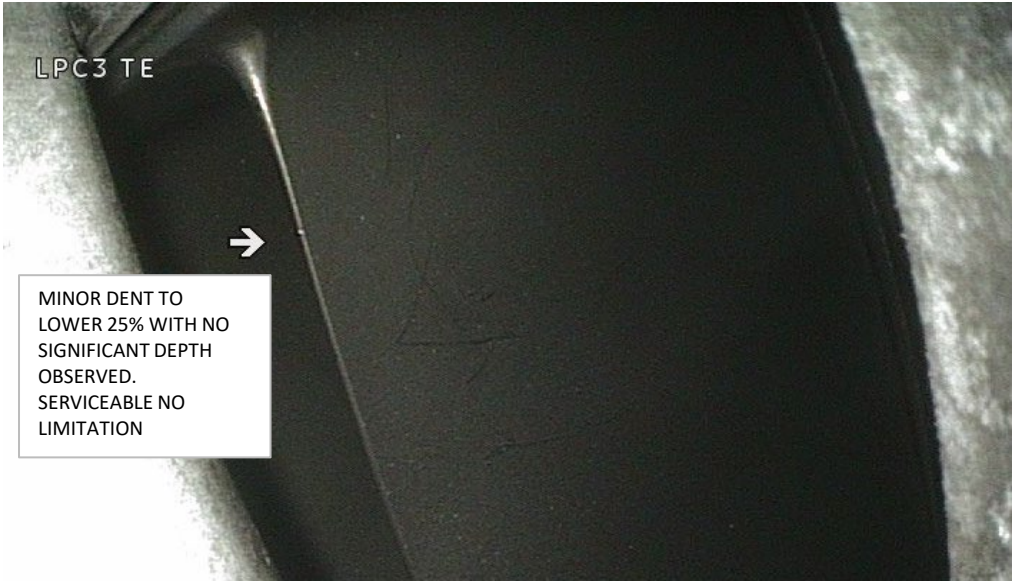
## LPC STAGE DEFECTS

MINOR ROUND BOTTOM DENT OBSERVED TO 1 OFF LPC3 TE BLADES ON LOWER 25% OF AIRFOIL BUT NOT AREA E. OBSERVED DEFECT WITHIN AMM 72-00-00-200-803-F00.F.(6).(f).1) OF LESS THAN 1MM DAMAGE DEPTH - SERVICEABLE NO LIMITATION. SEE APPENDIX A FOR DETAILS

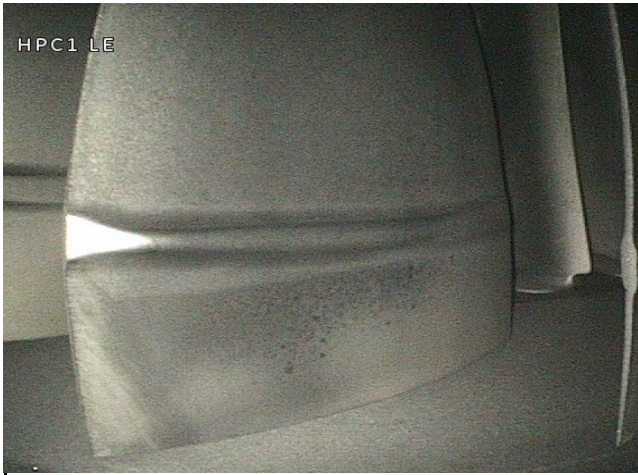
STAGE 1 HPC: SEVERAL HPC1 LE BLADES OBSERVED WITH MINOR DENTS TO LE IN LOWER 25%, DIM B & DIM A. ALL WITHIN AMM LIMITS. SEE DEFECTS PAGE FOR DETAILS

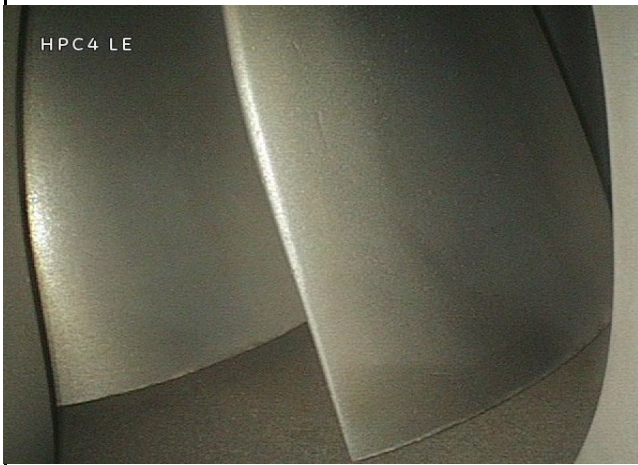
STAGE 4 HPC: MINOR DEFECTS OBSERVED TO HPC4 LE WITH DENTS IN LOWER 25% AND AIRFOIL CENTRE PANEL. DENTS HAVE NO SIGNIFICANT DEPTH AND SERVICEABLE - NO LIMITATIONS

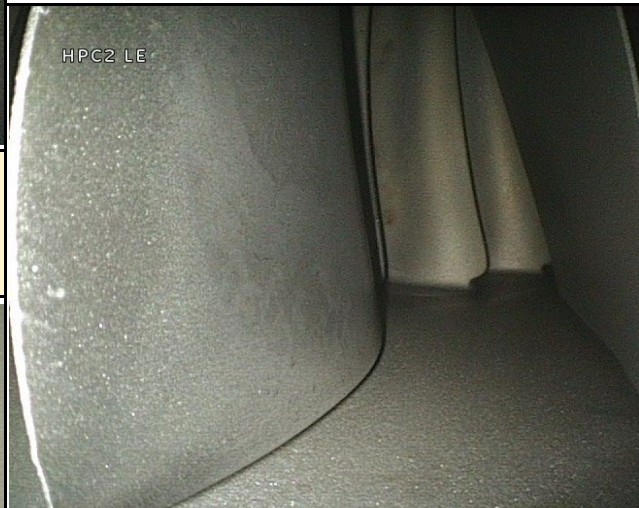
STAGE 2 HPC: SEVERAL HPC2 LE BLADES OBSERVED WITH MINOR DENTS TO LE IN LOWER 25%, DIM B & DIM A. ALL WITHIN AMM LIMITS. SEE DEFECTS PAGE FOR DETAILS. 1 OFF HPC2 BLADE OBSERVED WITH LE DENT IN AMM LIMITS

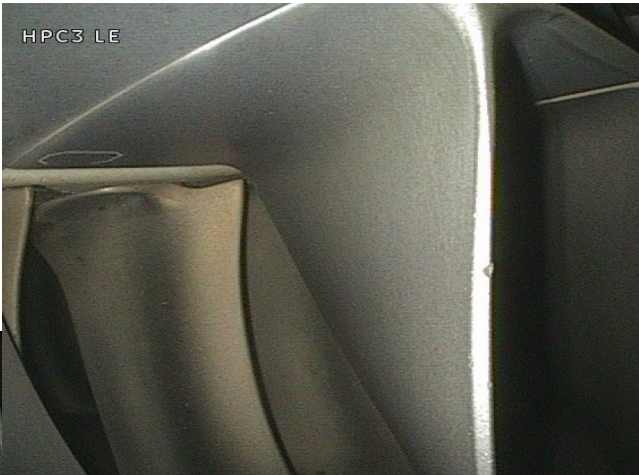
STAGE 3 HPC: SEVERAL HPC3 LE BLADES OBSERVED WITH MINOR DENTS TO LE IN LOWER 25%, DIM B & DIM A. ALL WITHIN AMM LIMITS. SEE DEFECTS PAGE FOR DETAILS. 1 OFF HPC3 BLADE OBSERVED WITH LE DENT IN AMM LIMITS. SHOP BLEND OBSERVED TO HPC3 TE ROOT RADIUS

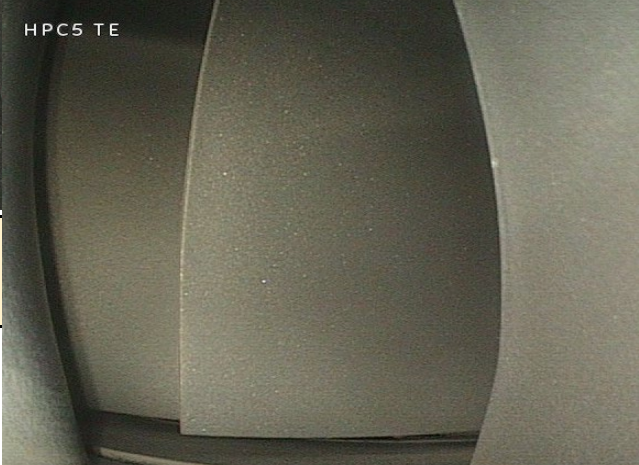
STAGE 5 HPC: SEVERAL HPC5 LE BLADES OBSERVED WITH MINOR DENTS TO LE IN LOWER 25%, DIM B & DIM A. ALL WITHIN AMM LIMITS. SERVICEABLE - NO LIMITATIONS

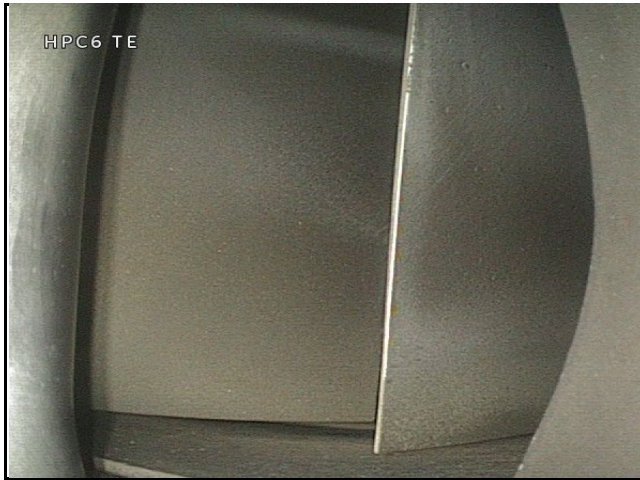
STAGE 6 HPC. DEFECTS OBSERVED TO TIP AREA, DIM.B & DIM.A WITHIN AMM LIMITS. TIP CURL OBSERVED TO 1 OFF HPC6 LE. DENT TO LE OBSERVED IN DIM.B WITHIN AMM LIMITS.

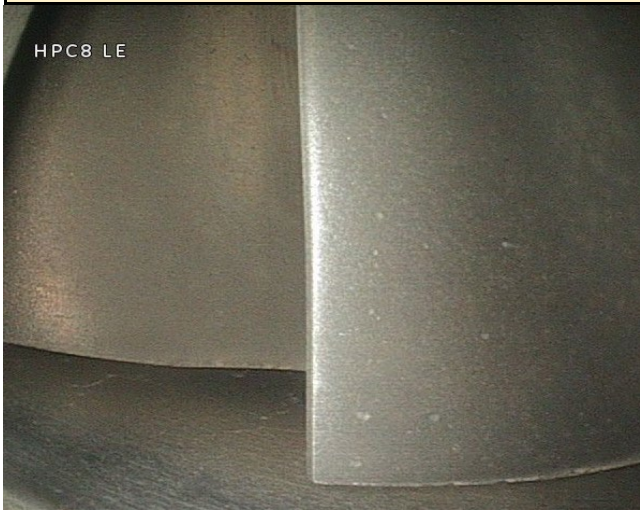
STAGE 8 HPC: MINOR DEFECTS OBSERVED TO LEADING EDGE WITH NO SIGNIFICANT DEPTH OF DEFECTS. 1 OFF HPC8 LE OBSERVED WITH MISSING TIP CORNER. ALL DEFECTS OBSERVED WITHIN AMM LIMITS

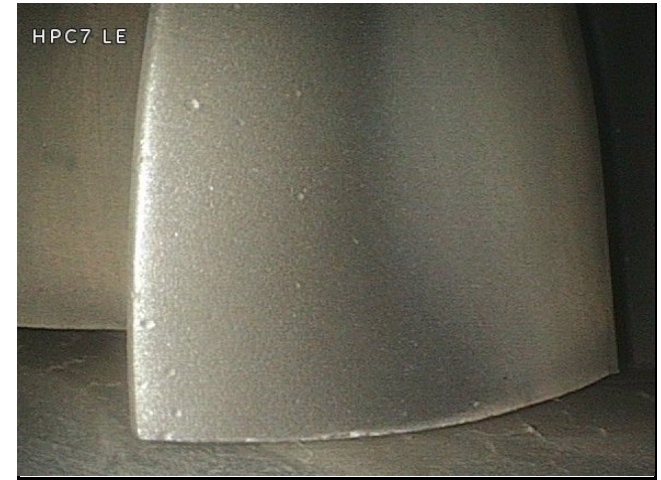
STAGE 7 HPC: MINOR DEFECTS OBSERVED TO LEADING EDGE WITH NO SIGNIFICANT DEPTH OF DEFECTS

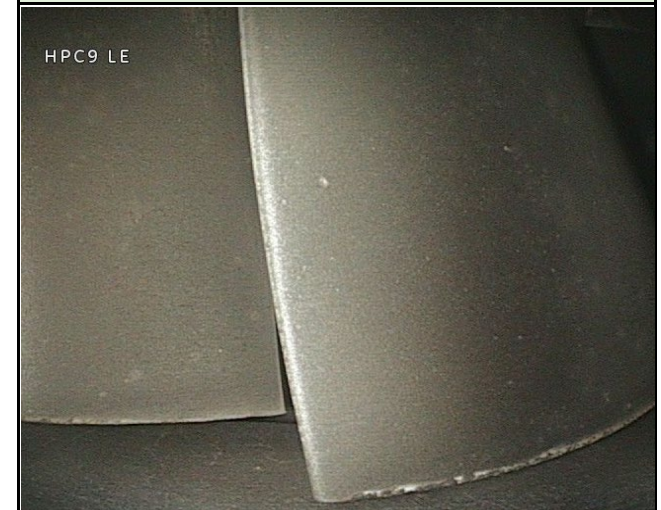
STAGE 9 HPC: NO STAGE DEFECTS OBSERVED

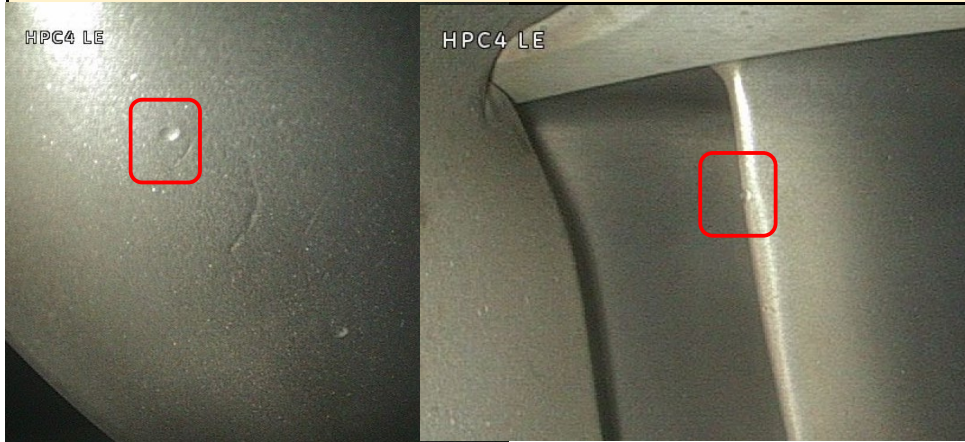
SEVERAL HPC4 LE BLADES OBSERVED WITH MINOR ROUND BOTTOM DENTS & IMPACTS TO LE IN LOWER 25% & AIRFOIL CENTRE PANEL, MAJORITY INSIGNIFICANT AND HAD NO SIGNIFICANT DEPTH. WITHIN AMM LIMITS

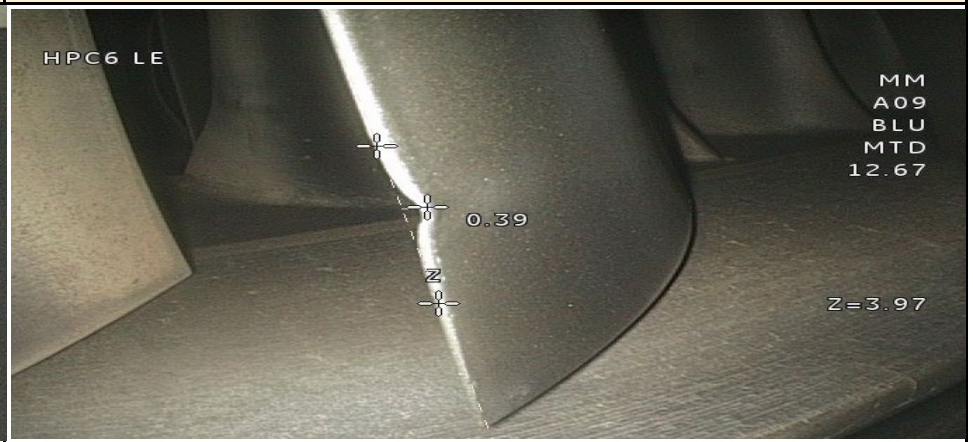
1 OFF HPC6 LE BLADE OBSERVED WITH DENT / IMPACT DAMAGE TO LE IN DIM.B. DAMAGE DEPTH MEASURED AT 0.39 MM DEFLECTION FROM ORIGINAL CONTOUR. OBSERVED DAMAGE WITHIN AMM 72-00-00-200-804-F00 5.G.(2)(k).2) OF UPTO 1.5MM ALLOWABLE DEFLECTION FROM ORIGINAL CONTOUR. SEE APPENDIX E FOR CLARIFICATION.

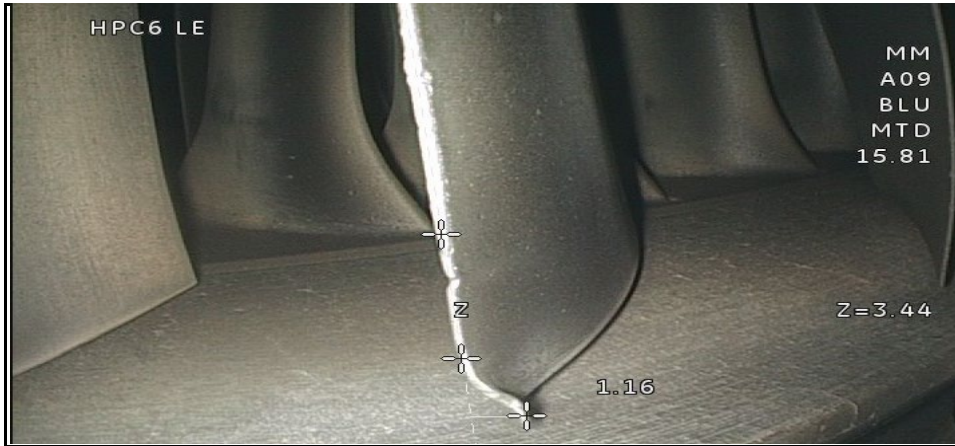
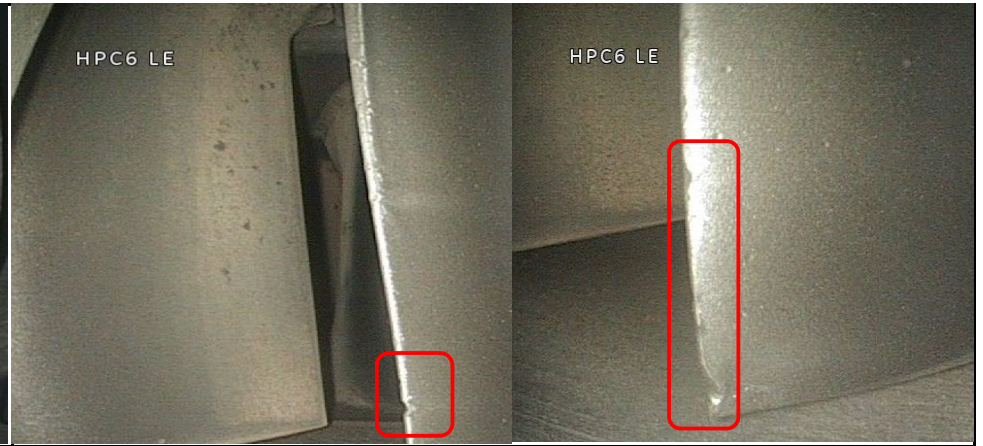
1 OFF HPC6 LE BLADE OBSERVED WITH SIGNIFICANT TIP CURL MEASURING 1.16MM DEFLECTION FROM ORIGINAL CONTOUR. OBSERVED DAMAGE WITHIN AMM 72-00-00-200-804-F00 5.G.(2)(n).2 OF UPTO 50% OF HPC5-9 STAGES WITH RADIAL DEFLECTION OF UPTO 7.6MM CHORD SPAN AND DOESN'T ENGAGE WITH STATIC PARTS OF ENGINE DURING OPERATION.SERVICEABLE - NO LIMITATION. SEE APPENDIX F FOR CLARIFICATION.

SEVERAL HPC6 LE BLADES OBSERVED WITH MINOR ROUND BOTTOM DENTS, IMPACTS & NICKS TO LE IN DIM.B, DIM.A & BLADE TIP. MAJORITY HAD NO SIGNIFICANT DEPTH. WITHIN AMM 72-00-00-200-804-F00 5.G.(2)(k).1); 5.G.(2)(l)1) & 5.G.(2).(m). SEE APPENDIX E, G & H FOR CLARIFICATION.

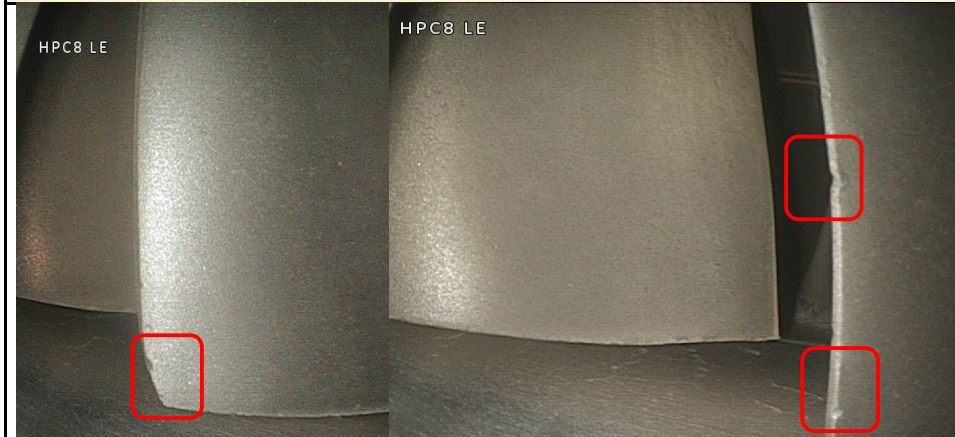
SEVERAL HPC8 LE BLADES OBSERVED WITH MINOR ROUND BOTTOM DENTS, IMPACTS & NICKS TO LE IN DIM.B, DIM.A & BLADE TIP. MAJORITY HAD NO SIGNIFICANT DEPTH. ONE OFF HPC8 LE OBSERVED WITH MISSING TIP CORNER. ALL DEFECTS WITHIN AMM 72-00-00-200-804-F00 5.G.(2)(k).1); 5.G.(2)(l)1) & 5.G.(2).(m). SEE APPENDIX E, G & H FOR CLARIFICATION.

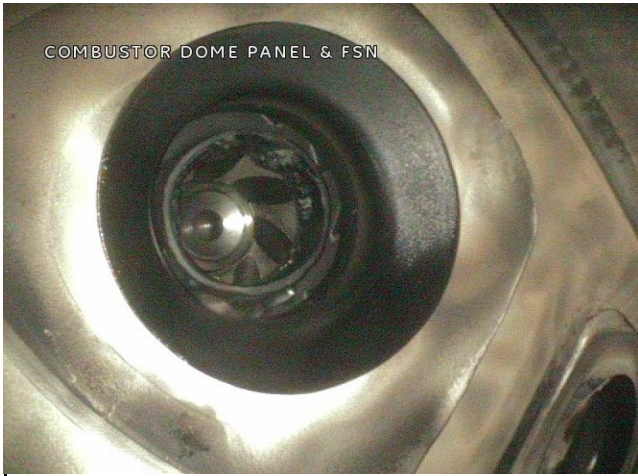
COMBUSTOR DOME PANEL & FSN

COMBUSTION CHAMBER: MINOR DEFECTS OBSERVED. SEE COMBUSTOR DEFECTS PAGE. SERVICEABLE - NO LIMITATIONS

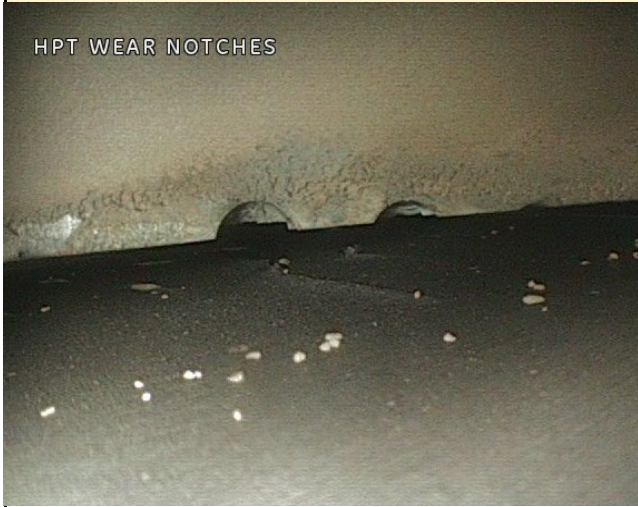
HPT WEAR NOTCHES

HPT BLADES: 3 BLADES OBSERVED WITH 3 NOTCHES, 1 BLADE OBSERVED WITH 2 NOTCHES.

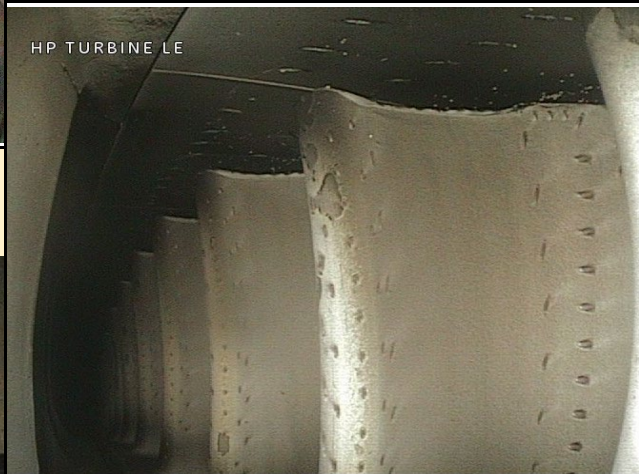
HP TURBINE LE

HP TURBINE BLADES: T.B.C LOSS OBSERVED TO MAJORITY OF BLADE LE. ACCEPTABLE IN ANY AMOUNTS - SERVICEABLE - NO LIMITATION

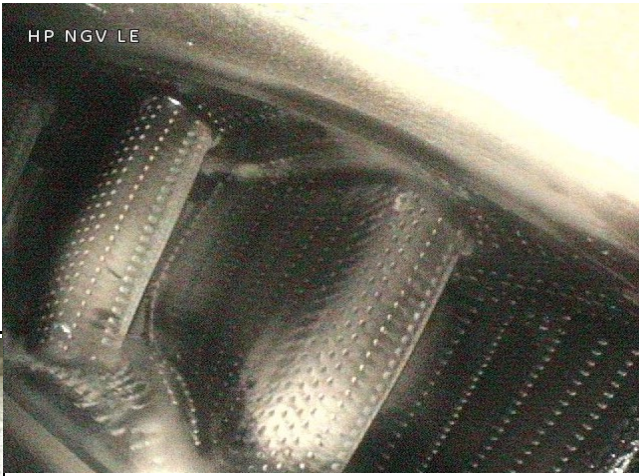
HP NGV LE

HPT NOZZLE: SEVERAL HPNGV OBSERVED WITH TE CRACKING & MISSING T.B.C.1 OFF TE OBSERVED WITH MISSING MATERIAL. ALL OBSERVED DEFECTS WITHIN AMM LIMITS. SERVICEABLE - NO LIMITATION

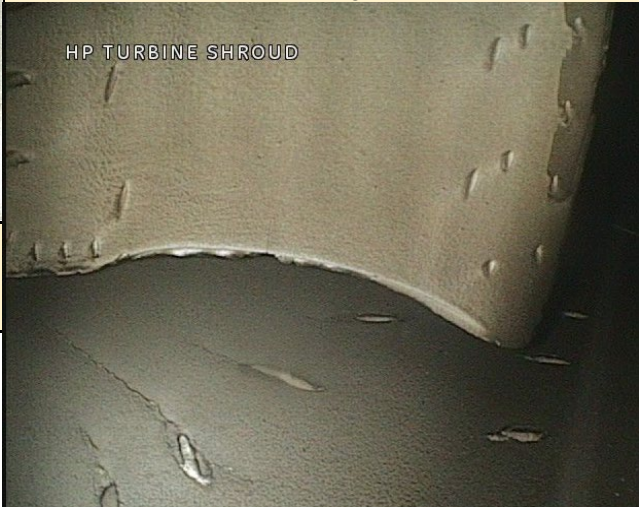
HP TURBINE SHROUD

HP TURBINE SHROUD: SEVERAL HPT SHROUD PANELS OBSERVED WITH AXIAL CRACKS FROM COOLING HOLES. ACCEPTABLE IN ANY AMOUNT. SERVICEABLE - NO LIMITATION

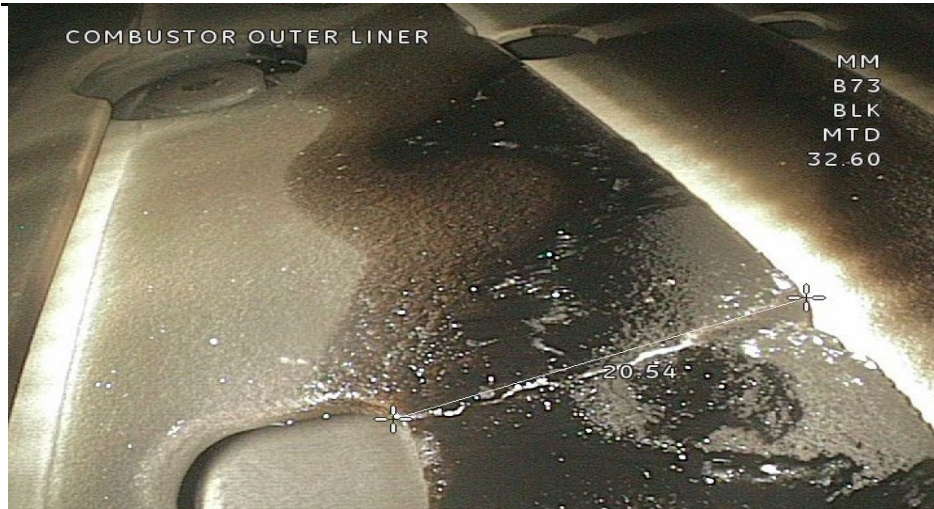
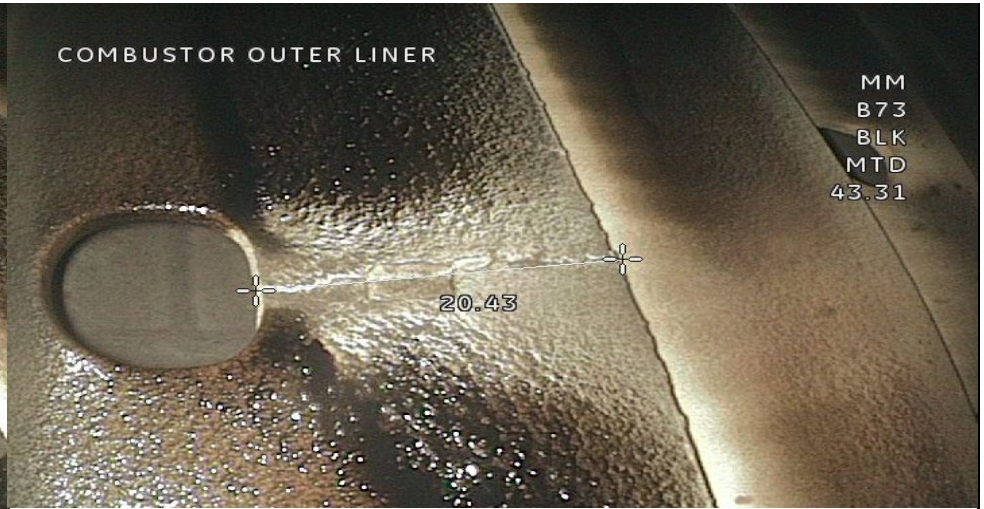
1 OFF COMBUSTOR OUTER LINER OBSERVED WITH AXIAL CRACK MEASURING 20.54MM AND PROPAGATING LESS THAN ONE PANEL WIDTH.ACCEPTABLE AS PER 72-00-00-200-805-F00.7.G.(3).(a).1) OF ANY AMOUNT PERMITTED IF LESS THAN ONE PANEL WIDTH. SEE APPENDIX I FOR CLARIFICATION

1 OFF COMBUSTOR OUTER LINER OBSERVED WITH AXIAL CRACK MEASURING 20.43MM AND PROPAGATING LESS THAN ONE PANEL WIDTH.ACCEPTABLE AS PER 72-00-00-200-805-F00.7.G.(3).(a).1) OF ANY AMOUNT PERMITTED IF LESS THAN ONE PANEL WIDTH. SEE APPENDIX I FOR CLARIFICATION.

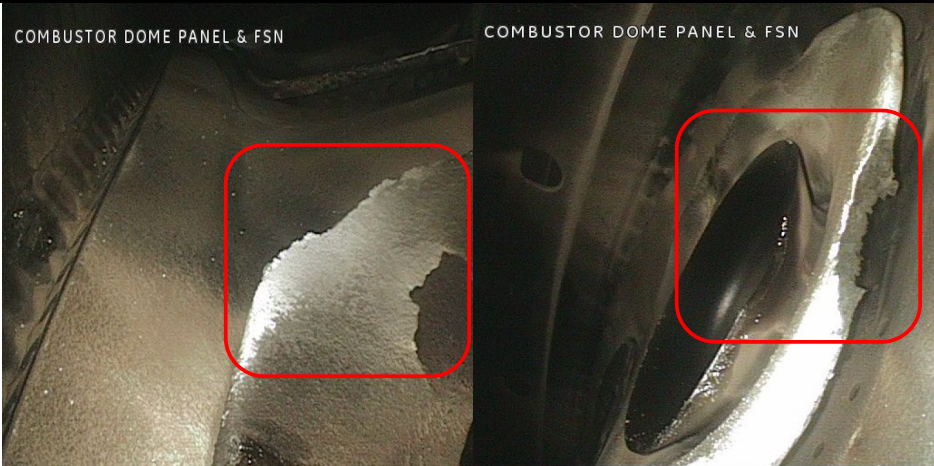
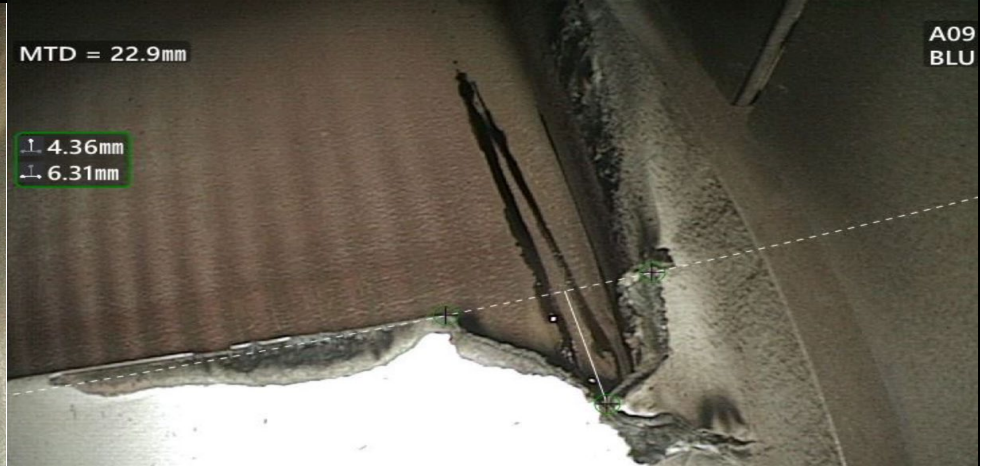
SEVERAL COMBUSTOR DOME PANEL EXTENSIONS OBSERVED WITH BURNBACK AND SMALL AMOUNT OF MISSING MATERIAL.ACCEPTABLE AS PER 72-00-00-200-805-F00.7.G.(2).(i).1) OF ANY AMOUNT PERMITTED IF LESS THAN 15 DOME COOLING HOLES EXPOSED. CURRENTLY NO DOME COOLING HOLES EXPOSED. SEE APPENDIX J FOR CLARIFICATION.

1 OFF HPNGV OBSERVED WITH MISSING MATERIAL TO TE. MISSING MATERIAL MEASURED AT 4.36MM AXIAL LENGTH .ACCEPTABLE AS PER 72-00-00-220-801-F00.8.G.(4).(c).1) OF UPTO 12.7MM AXIAL LENGTH PERMISSIBLE PER VANE. SERVICEABLE- NO LIMITATION. SEE APPENDIX K FOR CLARIFICATION.

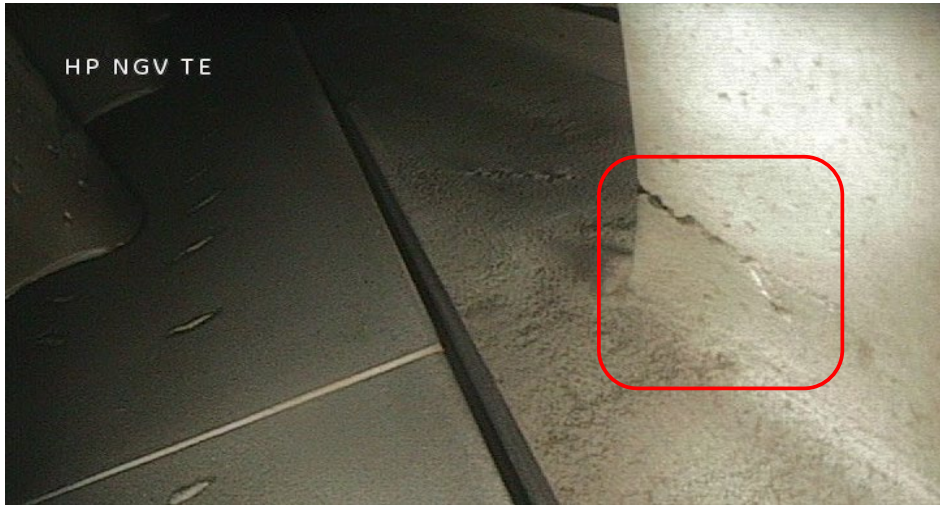
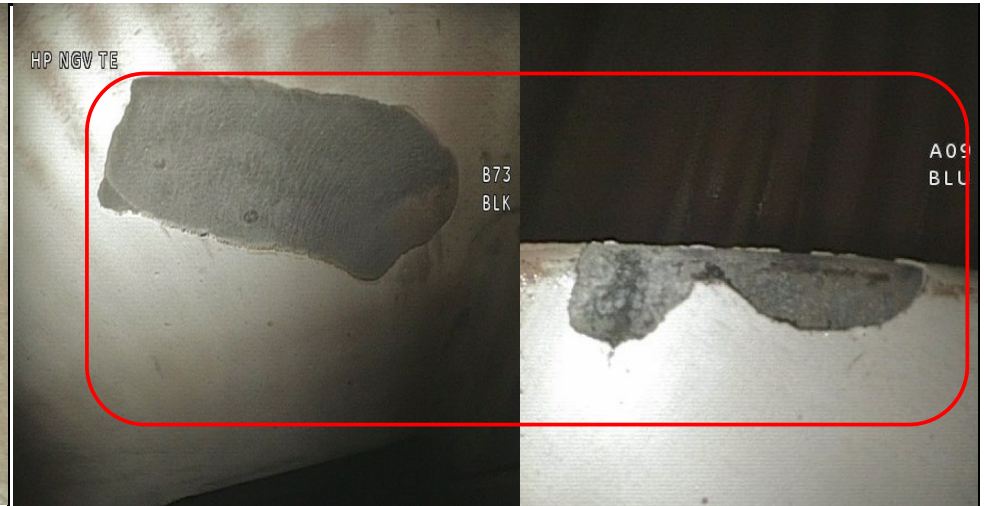
SEVERAL HPNGV TE OBSERVED WITH CRACKING TO TE. CRACKS.ACCEPTABLE IN ANY AMOUNTS AS PER 72-00-00-220-801-F00.8.G.(4).(a).1). SERVICEABLE- NO LIMITATION. SEE APPENDIX K FOR CLARIFICATION.

SEVERAL HPNGV TE OBSERVED WITH MISSING T.B.C TO BOTH CONCAVE AND CONVEX SURFACES.ACCEPTABLE IN ANY AMOUNTS AS PER 72-00-00-220-801-F00.8.G.2.(d).1) & (3).(c).1). SERVICEABLE- NO LIMITATION.

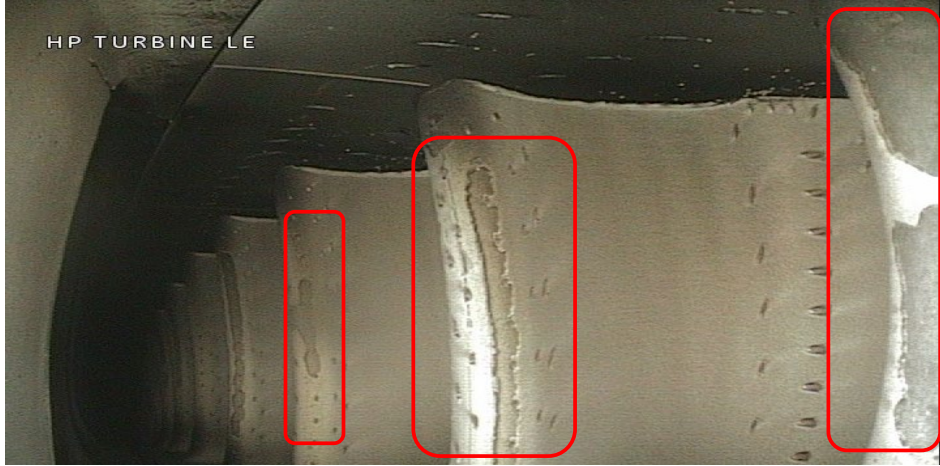
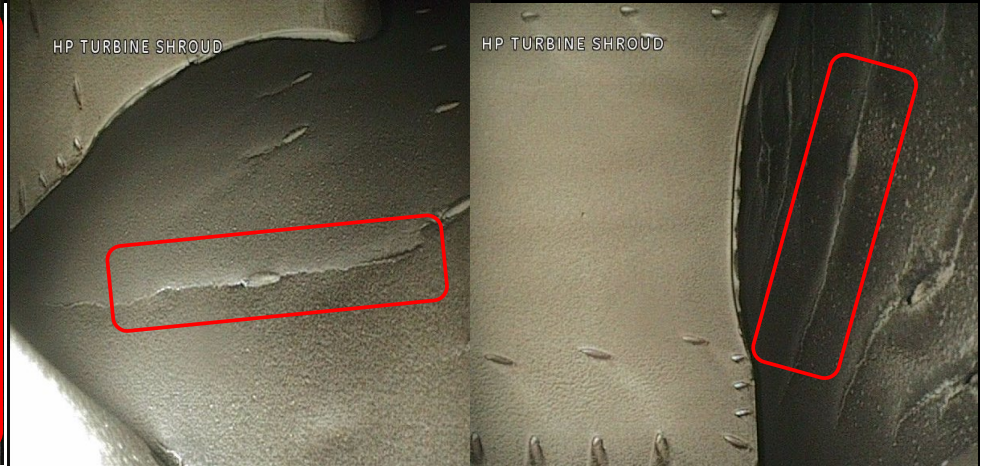
MAJORITY OF HP TURBINE BLADE LEADING EDGES OBSERVED WITH MISSING T.B.C..ACCEPTABLE AS PER 72-00-00-200-807-F00.10.G.(3).(g).1) OF ANY AMOUNT PERMITTED MISSING. SEE APPENDIX L FOR CLARIFICATION.

SEVERAL HPT SHROUD PANELS OBSERVED WITH AXIAL CRACKS STARTING FROM COOLING HOLES. ACCEPTABLE IN ANY AMOUNT AS PER AMM 72-00-00-200-815-F00.11.F.(1).(a).1) SERVICEABLE - NO LIMITATION. SEE APPENDIX M FOR CLARIFICATION.

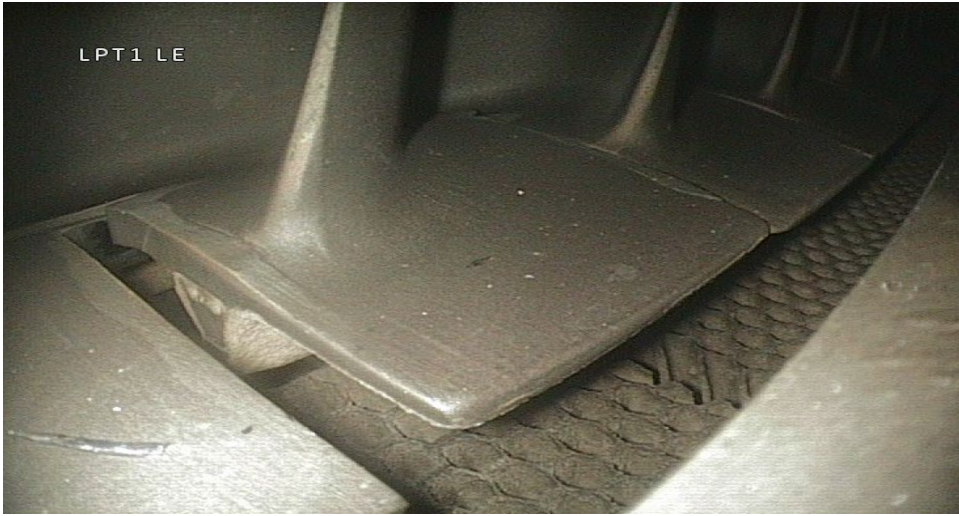
LPT 1 BLADES OBSERVED WITH GAP IN THE TIP SHROUD INTERLOCK. ACCEPTABLE AS PER AMM 72-00-00-200-808-F00.12.G.(2).(h).1.(a) THAT INTERLOCK FACES SHOW NO SIGN OF WEAR. SEE APPENDIX N FOR CLARIFICATION.

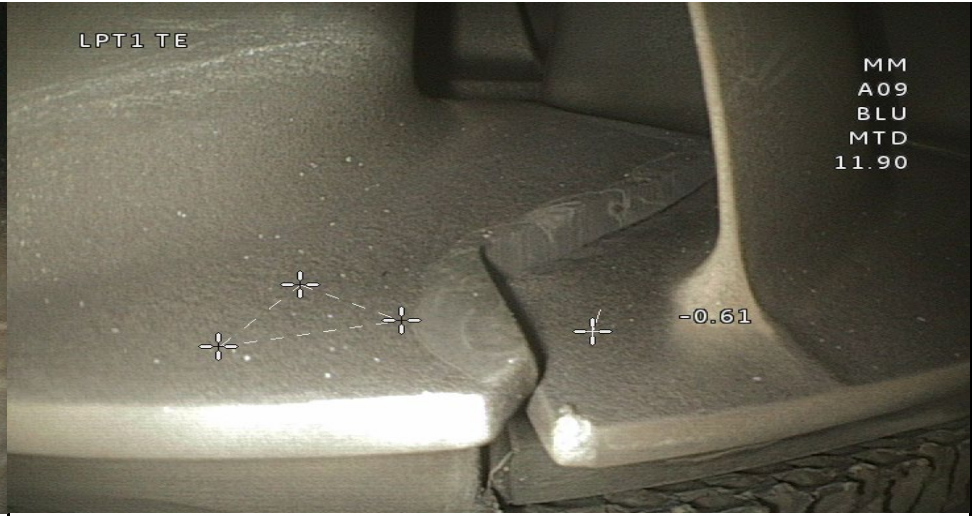
LPT 1 BLADES OBSERVED WITH OUT OF FLUSH IN THE TE TIP SHROUD INTERLOCK. OUT OF FLUSH MEASURED AT - 0.61MM. WITHIN AMM 72-00-00-200-808-F00.12.G.(2).(j).1.(a) THAT INTERLOCK FACES ARE NO MORE THAN 1.20MM OIUT OF FLUSH. SEE APPENDIX O FOR CLARIFICATION.

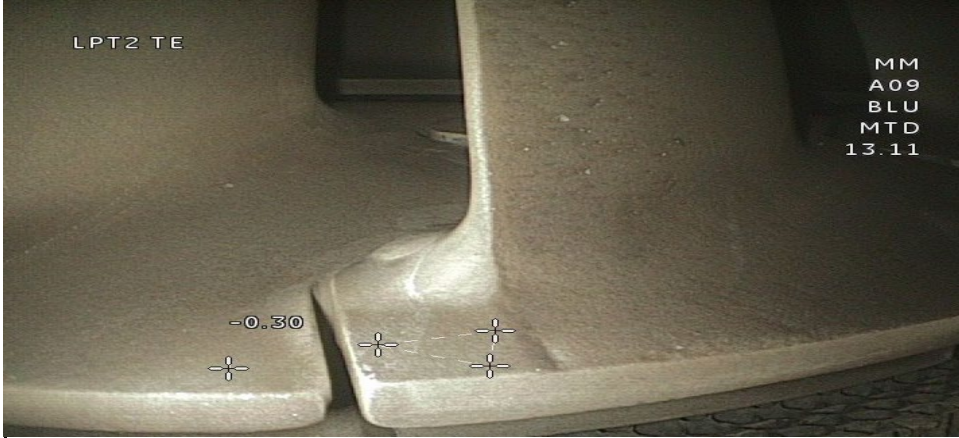
LPT 2 BLADES OBSERVED WITH OUT OF FLUSH IN THE TE TIP SHROUD INTERLOCK. OUT OF FLUSH MEASURED AT - 0.30MM. WITHIN AMM 72-00-00-200-808-F00.12.G.(2).(j).2.(a) THAT INTERLOCK FACES ARE NO MORE THAN 1.20MM OIUT OF FLUSH. SEE APPENDIX O FOR CLARIFICATION.
